Pioneer sound.vision.soul

VEHICLE APPLICATIONS (Double ISO/Double DIN Installation Kit)

RADIO INSTALLATION INSTRUCTIONS

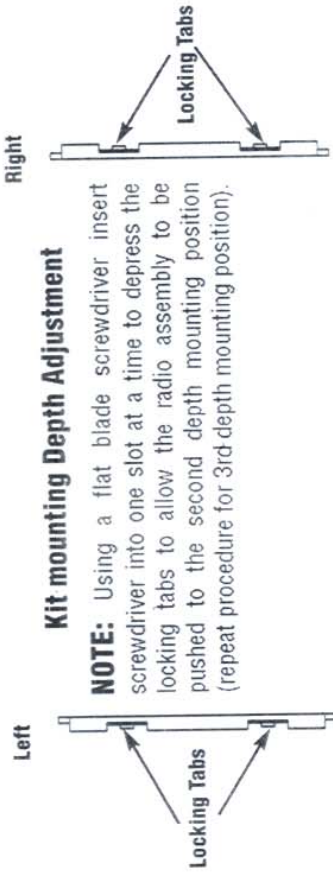
1. Carefully remove the top and bottom lip sections from the inside of the dash bezel's radio opening.
2. Attach rear support bracket to the rear of the ISO mount radios. (Support bracket may be located on top or bottom depending on vehicle)
3. **CAUTION:** See Special Notes section on page 2
4. Insert radio assembly into dash opening and lock into place.

5. Attach installation kit trim ring only after desired mounting depth has been achieved.

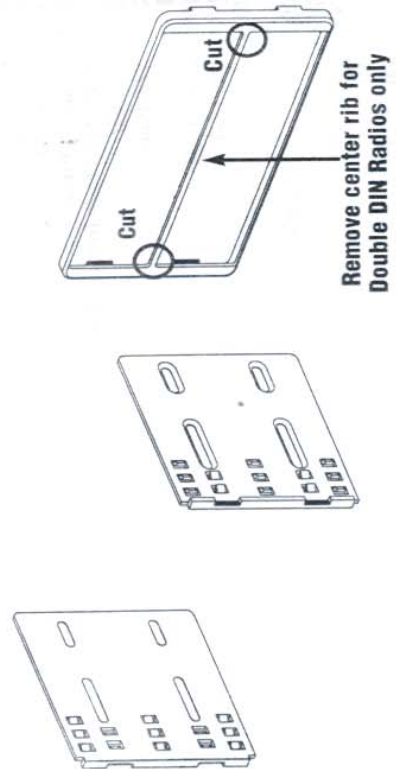
KIT ASSEMBLY INSTRUCTIONS

1. Using screws provided with radio components attach left and right side brackets to the (2) ISO mount components (do not tighten at this time).
2. Attach ISO trim ring to ISO mount brackets.
3. Adjust radio components forward or backward for desired look and tighten mounting screws when desired look is attained.
4. Remove trim ring from ISO mount assembly.
